# Manhole Inspection Summary

Manhole # S25MM1003MH

Insp Date: **11/6/06 10:28 AM**

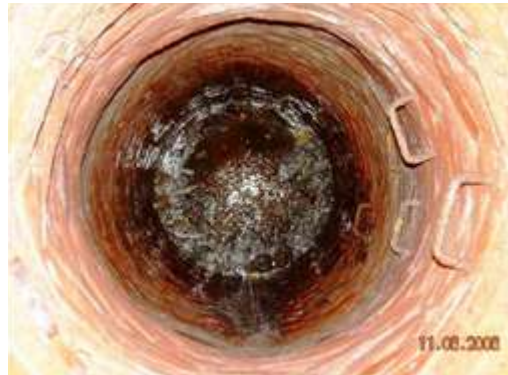
Top View

☒ **Debris** (not Condition related)

Count: **5** Missing: **2** ☒ **Corroded**

Corroded and missing steps. Channel debris.

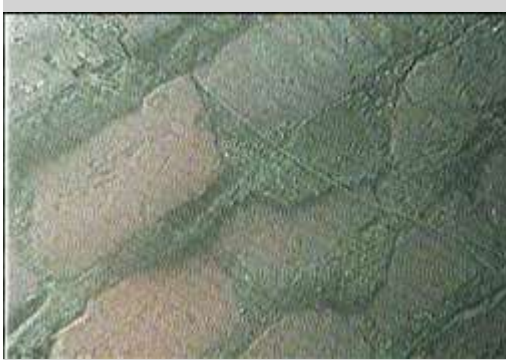
Defect

Condition: ☐ Sound ☐ Cracked ☒ **Root Intrusion** ☐ Loose Brick ☐ Deteriorated

Infiltration: ☐ None ☐ Joint ☐ Cracks ☐ Mortar ☒ **Roots** ☐ Wall

Corbel root intrusion and infiltration..

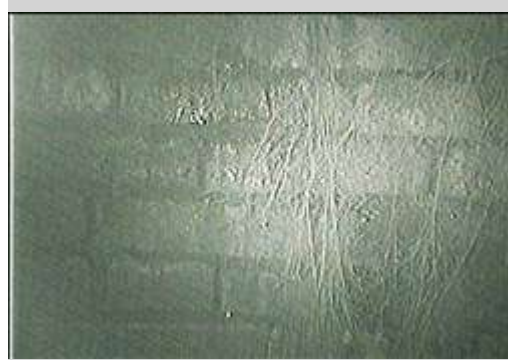
Defect

Condition: ☐ Sound ☐ Cracked ☒ **Root Intrusion** ☐ Loose Brick ☐ Deteriorated

Infiltration: ☐ None ☐ Joint ☐ Cracks ☐ Mortar ☒ **Roots** ☒ **Wall**

Barrel root intrusion and infiltration.
